## Case Study: Racking Risk Intervention

### *Hidden load paths, structural overload, and decisive engineering action*

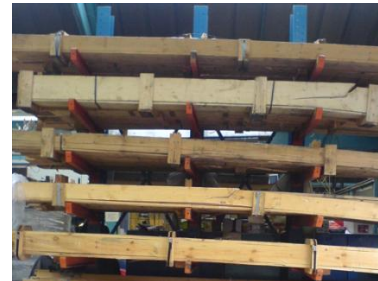
Operators had noticed that the racking “didn’t look right”, but no one could explain the cause. Noting that the photo exaggerates the effect, it was less visible to the naked eye. The most visible symptom was subtle but telling:

#### **Single M16 bolts securing the arms were repeatedly working loose.**

This indicated torsional loading, a sign that the arms were being twisted rather than simply loaded vertically.

- Sagging caused the middle arm to lose contact
- The load was redistributed onto the two outer arms
- The overhang created a moment arm, amplifying the bending moment at the column

- Total load:  $\approx 19.6$  kN ( $\approx 2$  tonnes)
- Each outer arm carried:  $\approx 9.8$  kN ( $\approx 1$  tonne vertical load)
- Nominal arm rating:  $\approx 750$  kg

- The bending moment at the column was significantly higher than the nominal rating assumed
- The single M16 bolt was experiencing cyclic torsional loading, explaining why it was loosening

- The racking was repositioned so that all boxes were fully supported across all three arms according to an optimal geometry calculation
- Overhangs were reduced
- Load paths were restored to the manufacturer's design intent
- Torsional loading on the arm brackets was removed
- The M16 bolts stopped loosening
